SYDNEY CBD CYCLEWAYS TRAFFIC SIGNALS OPTIMISATION

ROADS AND MARITIME SERVICES NSW

Project No: P0817

Version No: 002

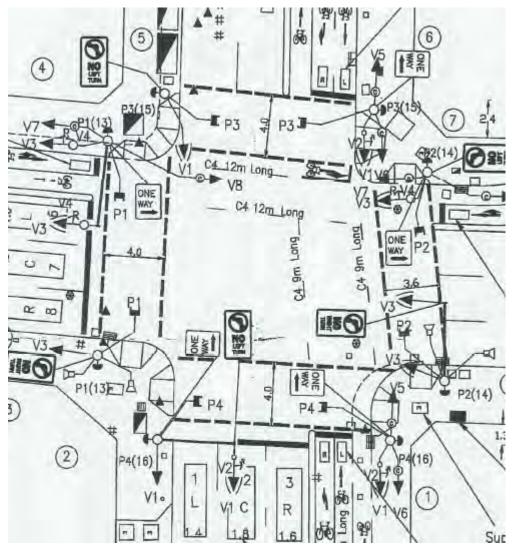
Figure 3.1 King and Kent Streets Layout

Two cycle ways intersect at this busy CBD intersection of two one-way streets. King Street is one-way eastbound and has a two-way cycleway on its northern side. Kent Street is one-way northbound and has a two-way cycleway on its eastern side. The extract from the design plan in Figure 3.1 shows the details of the intersection.

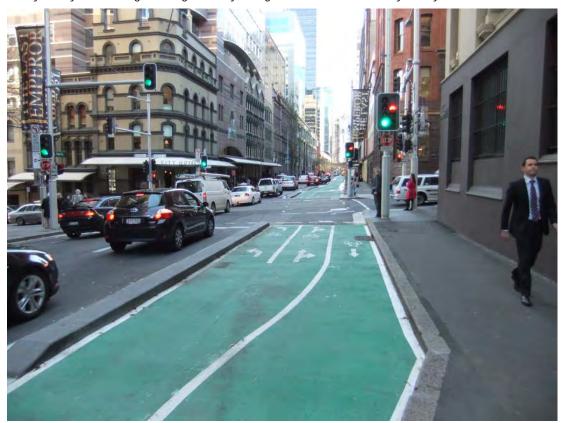
Figure 3.2 Kent Street looking north

The Kent Street cycleway has short storage bays at the intersection for northbound left turns and southbound right turns (see Figures 3.2 and 3.3), and there is a 'hook' turn storage bay for eastbound cyclists turning right to Kent Street (see Figure 3.4). This hook turn involves cyclists moving to the left of the cycleway and waiting for the green bicycle signal on the Kent Street cycleway.

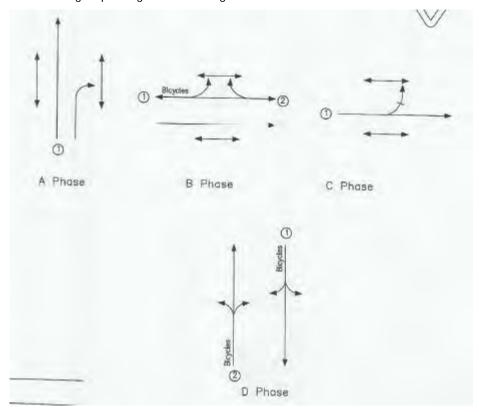
Figure 3.5 King and Kent Streets Phasing

The traffic signal phasing is shown in Figure 3.5 below.

The intended operation of this intersection is summarised in Table 3.1.

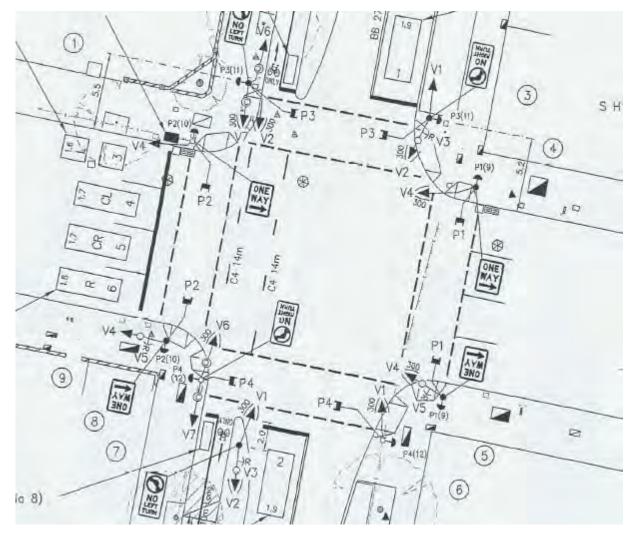
Figure 3.6 Albion and Bourke Streets Layout

The Bourke Street cycleway crosses Albion Street at this intersection. Albion Street is one-way eastbound, while Bourke Street is two-way and has a two-way cycleway on its western side. The extract from the design plan in Figure 3.6 shows the details of the intersection.

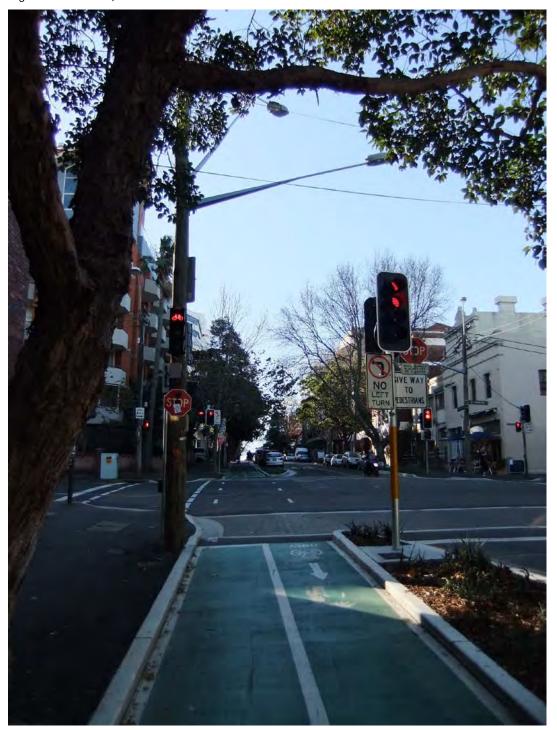
Figure 3.7 Bourke Street looking north

The Bourke Street cycleway has no storage bays at the intersection and because of Albion Street's oneway eastbound direction, cyclists are limited to southbound left turns and northbound right turns (see Figures 3.7 and 3.8).

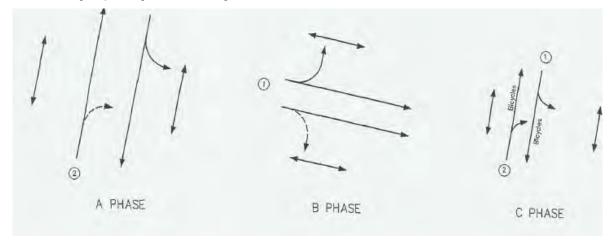
The traffic signal phasing is shown in Figure 3.9 below.

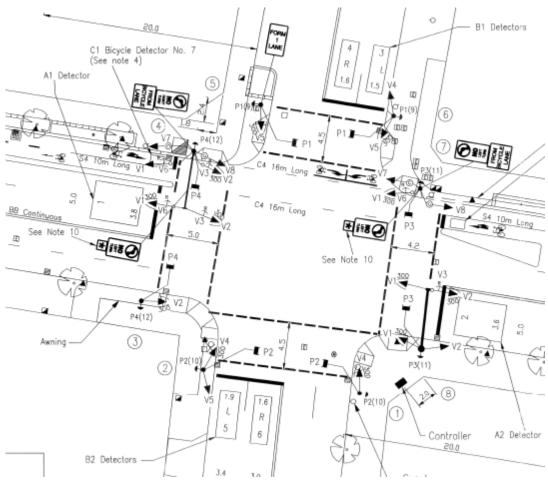
Figure 3.10 Union and Edward Streets Layout

The Union Street cycleway crosses Edward Street at this intersection. Union Street runs generally eastwest with the two-way cycleway on its northern side and one wide traffic lane in each direction. Edward Street is two-way and runs generally north-south. It has two lanes on its immediate approaches. The extract from the design plan in Figure 3.10 shows the details of the intersection.

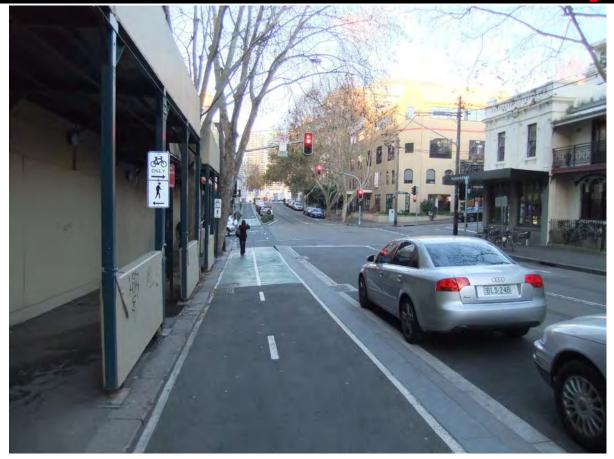
Figure 3.11 Union Street looking east

The Union Street cycleway has two 'hook' turn storage bays at the intersection to allow eastbound right turns and westbound left turns (see Figures 3.11, 3.12 and 3.13). These hook turns involve cyclists moving to the north of the cycleway and waiting for the green vehicle signal on the Edward Street approach.

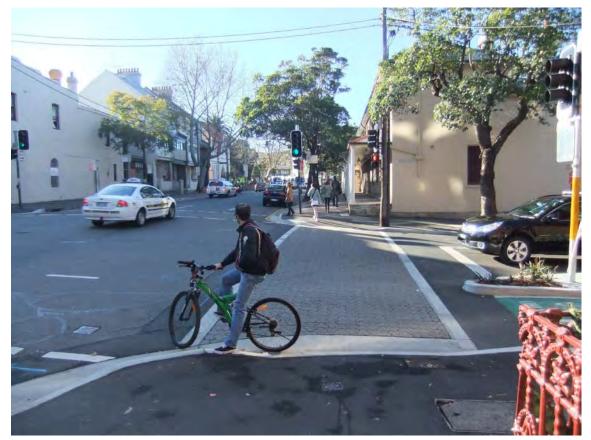
- many cyclists rode against the bicycle red signal, but during the Bourke Street green vehicle signal;
- many cyclists stopped beyond the stop line of the cycleway (see Figure 4.1 below);
- several cyclists were seen using the Bourke Street general lanes, rather than the cycleway; and
- in almost all cases, when cyclists stopped correctly behind the cycleway stop line, the bicycle phase (C phase) was successfully demanded and introduced. Occasionally, the cyclist arrived too late in the signal cycle for C phase to be introduced at that time. If the cyclist remained on the detector, however, C phase was introduced on the next signal cycle.

Figure 4.1 Cyclist waiting beyond cycleway stop line at Albion and Bourke Streets

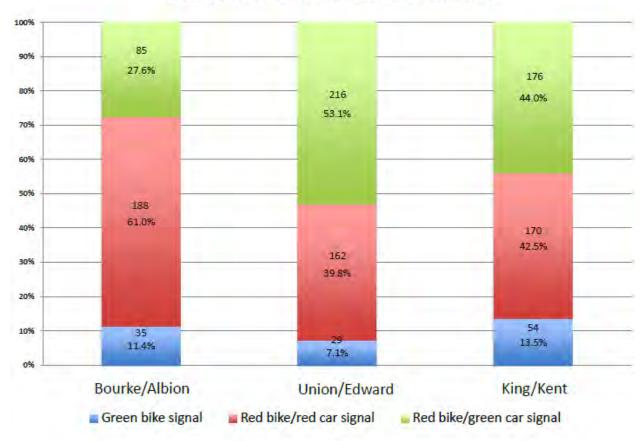
5.2 SIGNAL DISPLAYS ON CYCLISTS' APPROACH

Light signal as cyclists approach the intersection

It should be noted that other road users (including pedestrians) on 'minor' approaches would typically encounter red signals as they approach the intersection. Only motor vehicle drivers on the coordinated approaches (King Street or Albion Street) could expect a green signal.

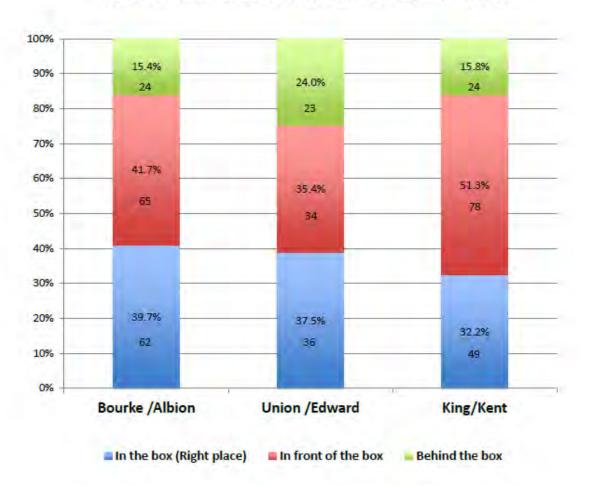
Where in relation to the detection box do cyclists stop?

- sample: stopping cyclists over three study periods (AM, Off Peak, and PM);
- only 32 40% of cyclists are stopping in the detection zone ('box'); and
- suggests little knowledge of how the detector works and also means they may be facing long waits for a green bicycle signal (except at King and Kent Streets where the bicycle phases are automatically introduced.

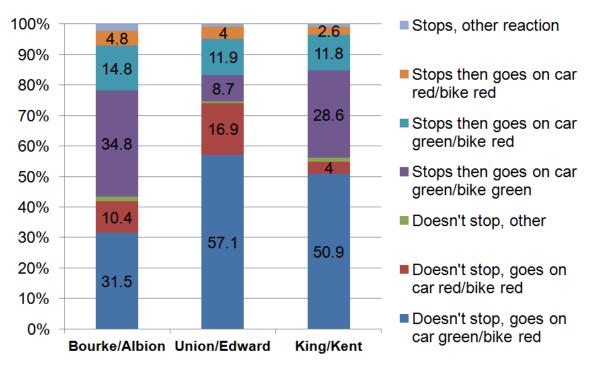
- many cyclists do not stop when faced with red bicycle signal;
 - Bourke/Albion ~ 45%;
 - King/Kent ~ 55%; and
 - Union/Edward ~75%.
- King and Kent Streets one way streets and low traffic on Union and Edward Streets may contribute to red light running;
- once stopped, most common reaction at King/Kent and Bourke/Albion is to cross with green bicycle signal; and
- at Union/Edward, even after stopping more cyclists go with green vehicle/bicycle red signal than green bicycle signal.

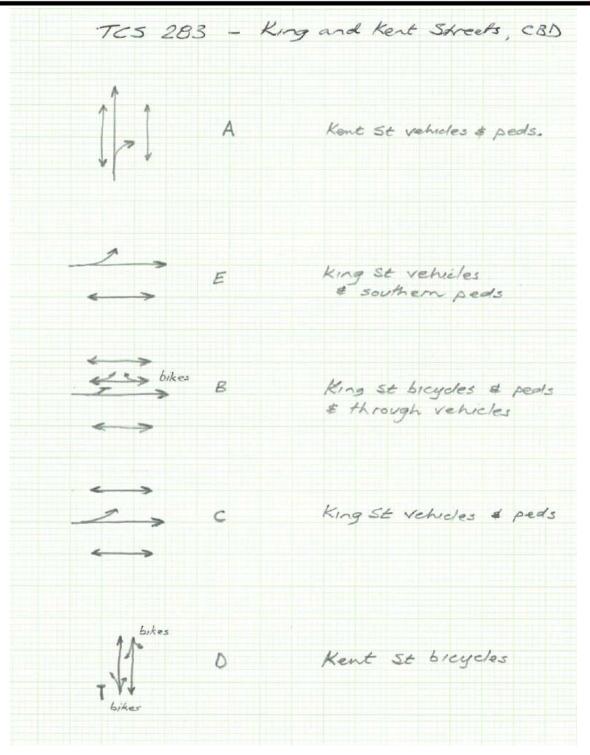
Figure 7.1 Proposed Phasing Arrangement at King and Kent Streets

A suggested solution to consider and (possibly trial) is to add another phase (say E phase) and modify the phase sequence. The additional phase would be for eastbound vehicles only and would provide a left turn green signal and a green through signal. (Pedestrians and cyclists would be held on red signals.) This phase would be the one to coordinate for eastbound cars from Sussex Street. At the end of this phase (exact duration to be determined but possibly around 15 seconds green time), a left turn yellow arrow would bring left turning traffic to a halt and a left turn red arrow would hold such traffic, while the existing B phase (the bicycle phase) was introduced. The remaining sequence would remain as currently operates, with the E phase time taken from the existing C phase. So the sequence would be A-E-B-C-D. The proposed phasing arrangement is shown in Figure 7.1 overleaf.
